**SERVICE BULLETIN SB-012****August 7<sup>th</sup>, 2026**

This Service Bulletin describes a potential cracking problem in specific lot numbers of Tempest<sup>®</sup> Spark Plugs manufactured between May 5, 2026 and July 29, 2026. It recommends immediate inspection of the affected spark plugs prior to your next flight and replacement of any cracked spark plugs. No action is required for Tempest<sup>®</sup> Spark Plugs purchased prior to May 5, 2026.

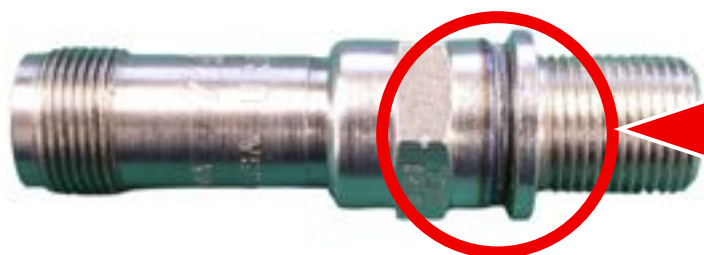
**Figure 1**

There have been field reports of cracks in Tempest<sup>®</sup> spark plugs. The area of damage is shown in Figures 1 & 2.

3. If an affected spark plug is found to be installed, remove the affected spark plug(s) from the engine and visually inspect for cracks as shown in Figures 1 and 2. Similarly, inspect any affected spark plugs in inventory.

5. If cracks are found, replace the spark plug(s). If replacing with new Tempest® spark plug(s), verify the new spark plugs carry compliance stamp SB012 as shown in Figure 4 or are outside the part number and lot numbers listed in Table 1 above.

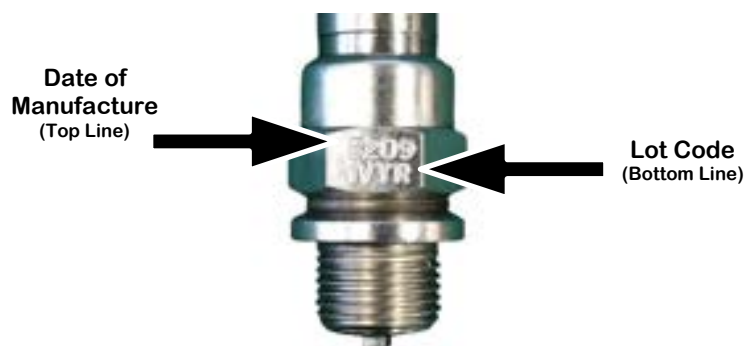
Visually inspect the spark plug for lot code per Figure 3. The lot code is stamped on the hex of the spark plug body as shown. Compare the stamped lot code to the affected part numbers and lot numbers listed in Table 1. Physical inspection of spark plugs is required. Remove from engine as required to confirm part number a lot code.

1. Determine if a spark plug is included in the affected lots (Table 1) using a visual inspection as shown in Figure 3 or by referencing an FAA 8130 from the latest spark plug installation as shown in Figure 5.
